Gjoa Haven

Permafrost Vulnerability Map
2014

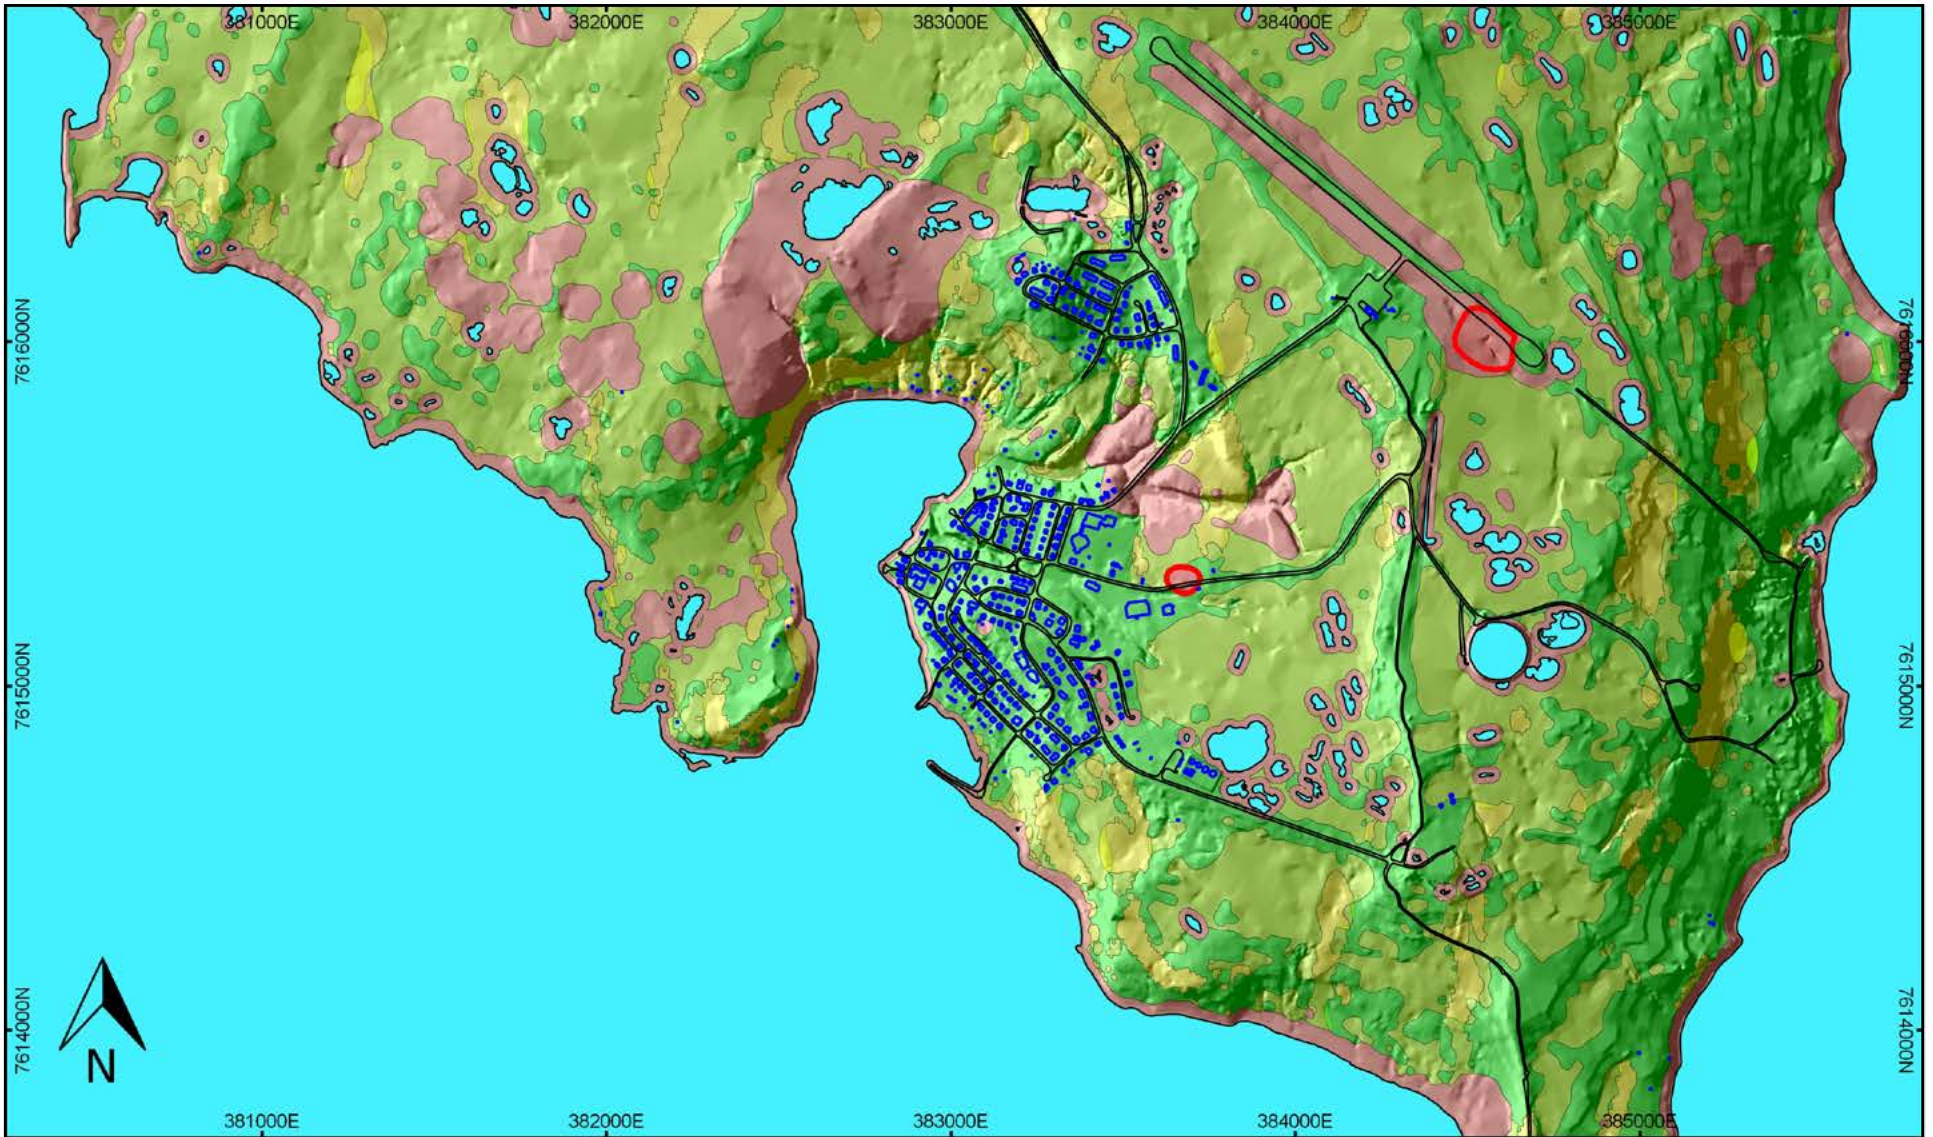
| 8 Unsuitable | Roads |
| 9 Marginal | Buildings |
| 11 Possible | Displacement |
| 12 Suitable | Water Bodies |
